ALL BOXED IN

Precast box culvert proves to be the perfect product to overcome multiple challenges while fixing a historic storm drainage line.

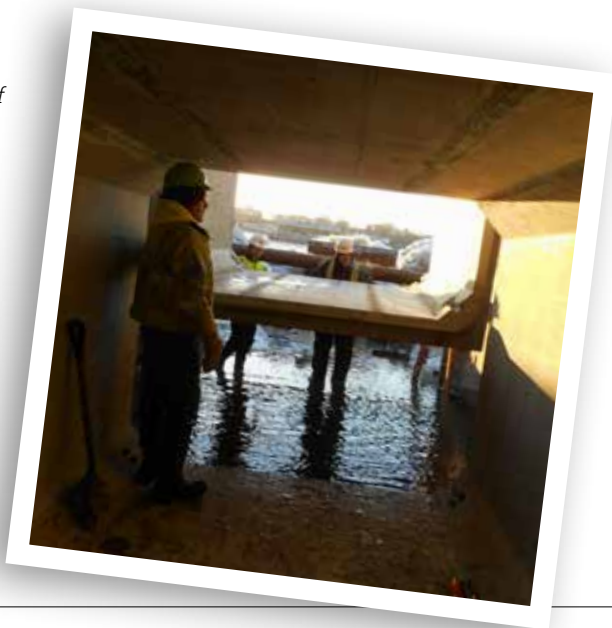
But there's nothing mysterious about this sinkhole. A portion of the city's storm drainage line collapsed, creating a sinkhole about 8 feet wide and about 20 feet deep.

The original lines constructed in the 1870s, consists of 5-foot-by-7-foot granite culvert. Later, 60 feet of timber box culvert was added, which feeds directly into the Penobscot River. The line failed at the juncture where timber met granite due to rotting timber sections.

The line provided storm drainage for a large portion of the city and served as an emergency sewer overflow. It needed to be reopened quickly to prevent potential flooding. Precast proved to be the best solution for replacing the old timber sections.

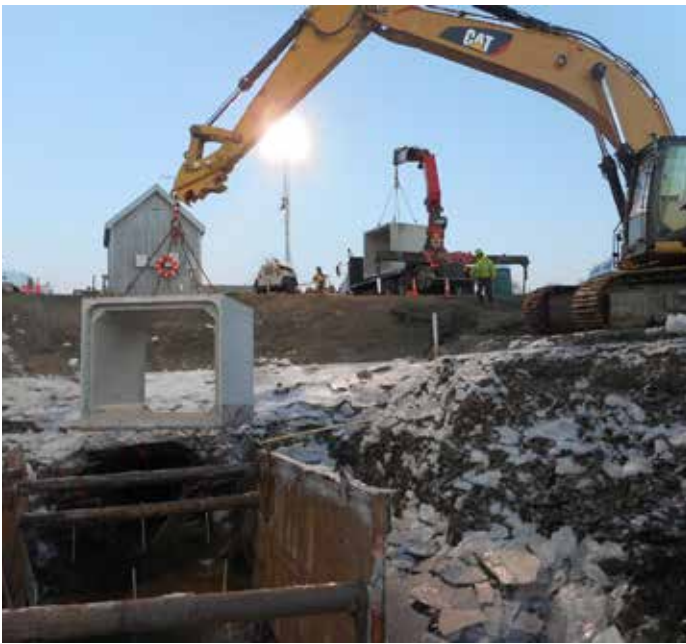
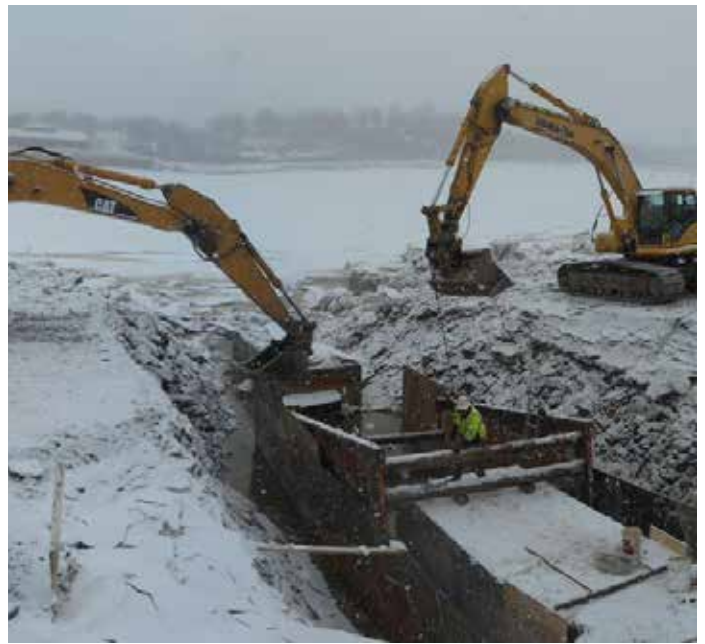
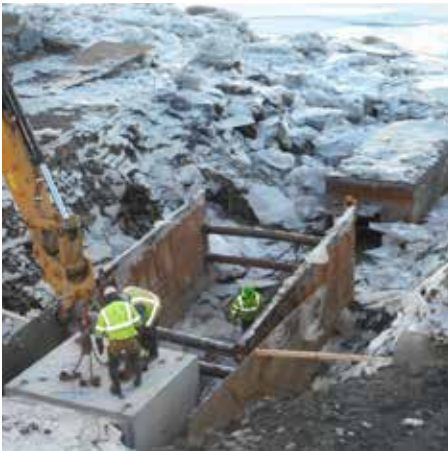
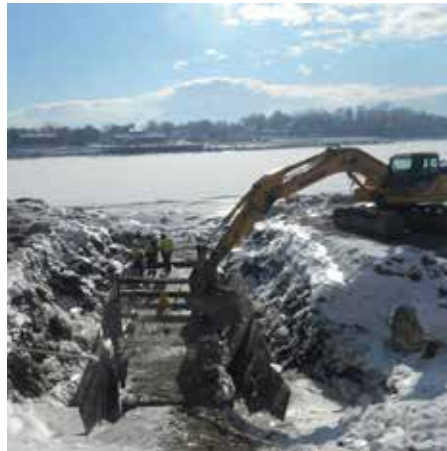
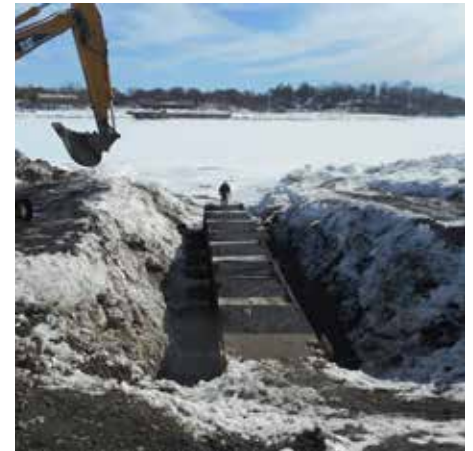
Workers had to contend with the depth of the excavation, frigid temperatures, ice and up to 14-foot-tall tides from the Penobscot River. At high tide, the entire area is underwater.

In the end, workers drilled into the granite and the adjoining precast component, inserted dowel rods and poured a concrete connecting piece between them. On Jan. 31, workers set the first three box culvert sections. They could only work when the tide was at its lowest point.

“Each time they set box sections they had about three hours of stone grading and setting time before the tide would get too high to efficiently do either,” Smith said. “The boxes were set at 0.5% slope from the existing granite to the final location of the outfall.”

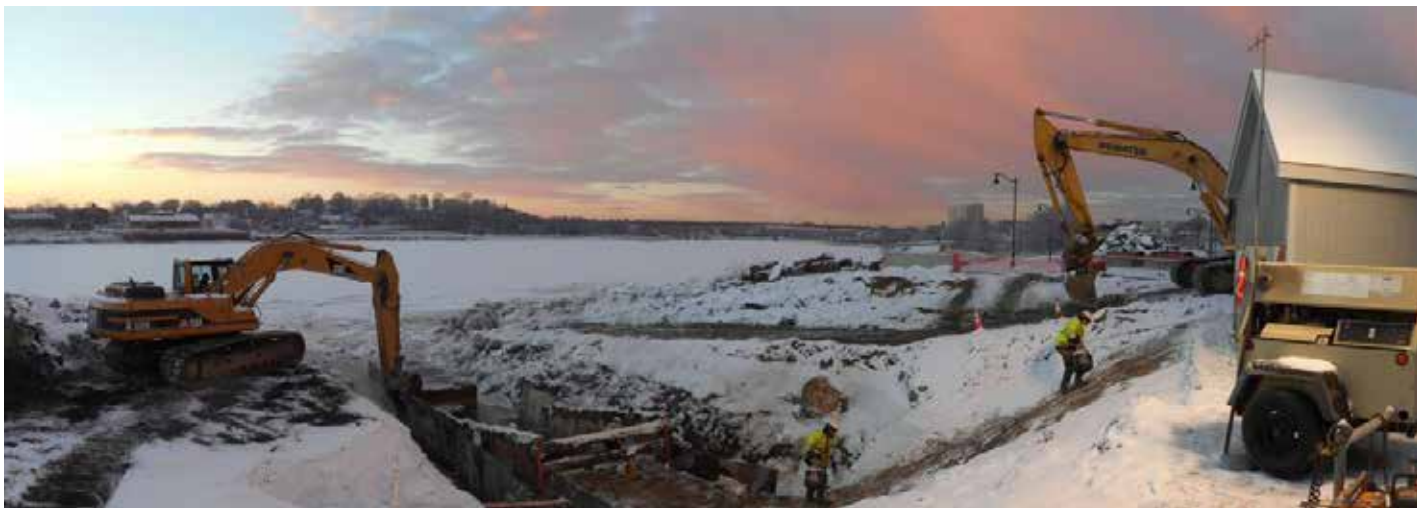
“We were virtually running around with 5-gallon buckets trying to throw enough sand on areas where people were walking so people didn’t slip and get hurt.”
